National Energy
Board

Investigation under the *National Energy Board Act*

**30 September 2009 release of gas and
subsequent fire at the Enbridge Gas
Distribution Inc. Lisgar Gate Station in
Mississauga, Ontario**

November 2012

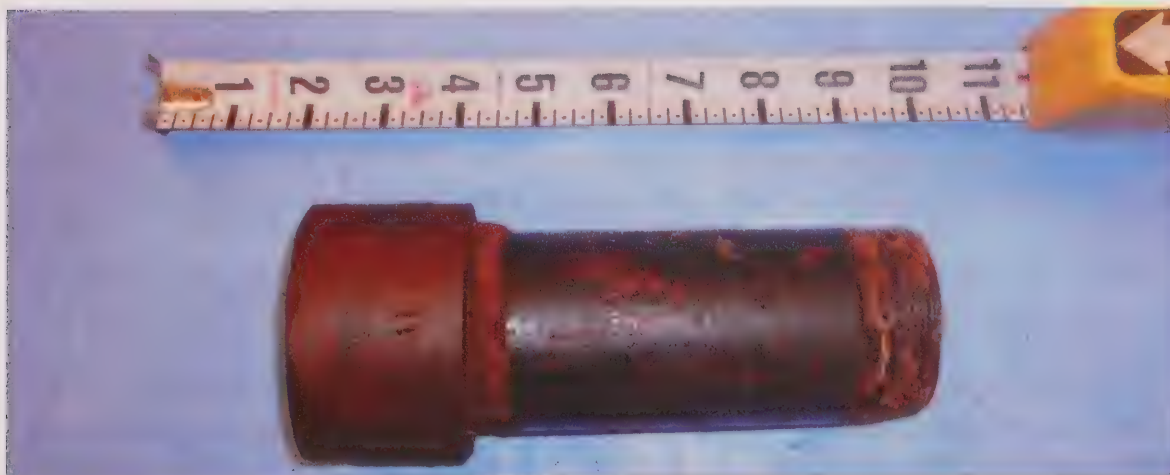
Figure 2. Pipe nipple that had been installed in the centre of the flange.

EGD contracted a third party to conduct a metallurgical failure analysis of the physical evidence gathered at the site, which included the blind flange and the nipple that had been installed in the centre of the blind flange. The nipple, shown in Figure 2 below, was threaded at one end and capped at the other. The independent laboratory examination determined that the measurements of the nipple were typical of a NPS 2 Schedule 80 pipe and that the chemical composition, microstructure and hardness conformed to that required by ASME SA 105-1989.

The metallurgical examination of the pipe nipple noted dents on the nipple cap and damage to the threads. The examination also revealed that the threaded section of the nipple had been bent and that thread crests were deformed. Damaged threads were also noted on the blind flange where the nipple had been attached.

NEB staff developed schematics and calculations to determine the rotational movement required to create the conditions that could have resulted in failure of the nipple. These calculations are provided in Appendix II. The calculations support the conclusion that if the contractor completed the second rotational movement of the section of pipe being welded, as interviews revealed, then this section of pipe would have contacted the nipple and possibly bent it as the pipe was moved into its desired position.

When asked if the damage observed on the nipple and blind flange was consistent with this possible scenario, the author of the metallurgical examination indicated that it was.

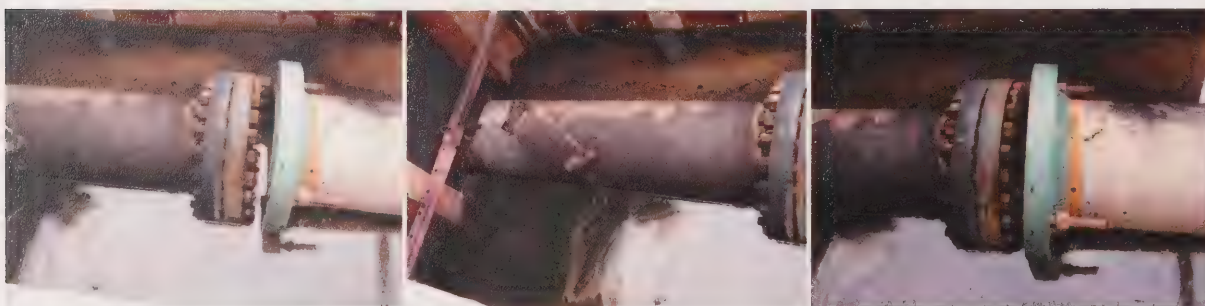
Figure 3. Photos showing the valve and nipple in the pipe close to the blind flange - Provided by TSSA

Photos taken after the incident revealed that there was a blow-down nipple installed on the pipe within ten feet of the blind flange which could have been used to evacuate gas from the pipe. The investigation also revealed that EGD had planned to install a 2-inch valve and another short nipple to the nipple already on the blind flange to enable evacuation of gas from the section of pipe that was to be pressurized. The contractor informed EGD that they were introducing a hazard with this configuration, and the contractor and the company agreed to install the blind flange with a nipple and cap only. From the blind flange, the pipeline extended approximately 300 yard to a 24-inch line valve. EGD decided to keep this line valve open to enable detection of leaks. Consequently, with the line valve open, this section of pipe was at line pressure of 370 psi, even though it was not needed for system operation. This decision unnecessarily introduced a significant hazard to the workers.

The practice of allowing a blind flange to contain a nipple to enable the evacuation of gas prior to new pipe being welded to existing pipe system is a common practice in pipeline construction. This allows the continued operation of the system. Interviews revealed that this was typical practice for distribution pipeline systems. Some company practices require a closed valve

upstream of a blind flange that contains a nipple, or at a maximum one pipe length⁶ from the flange, to allow a margin of safety in the event that the nipple is damaged or fails during construction activities. This practice limits the volume of gas release at most to that contained in one length of pipe. In the case of this incident, the duration of the release would have been significantly shorter had the line valve been closed, even with 300 feet of line pipe under pressure, and it likely would have resulted in less damage.

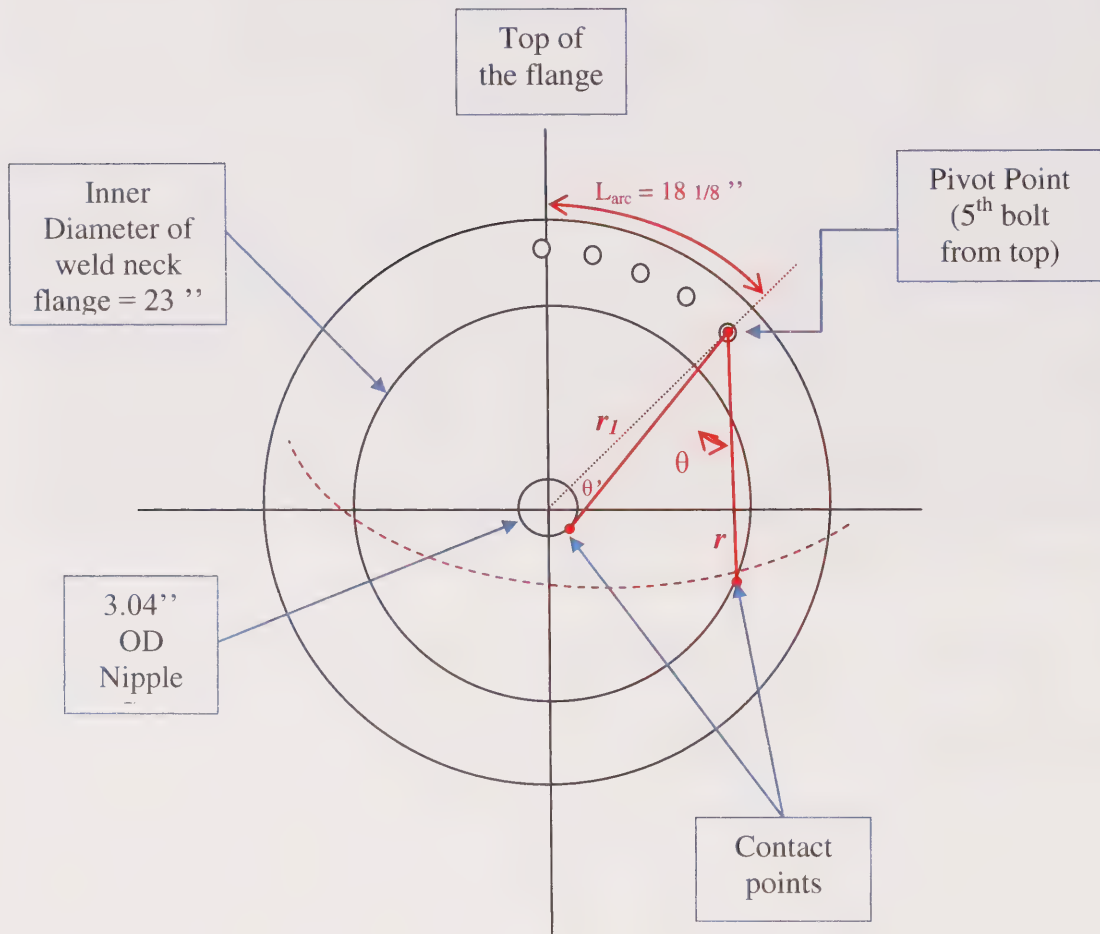
Figure 1: Schematic of the flanges and nipple assembly (not to scale)

This schematic represents the flange and the nipple prior to the rotation movement initiated for completing the cap weld on the 45° tee connection. Calculations below will determine the angle of rotation θ , which would be necessary for the inside surface of the weld neck flange to contact the nipple cap using the 5th bolt from the top as a pivot point, as per the rotation movement that occurred just prior to the incident.

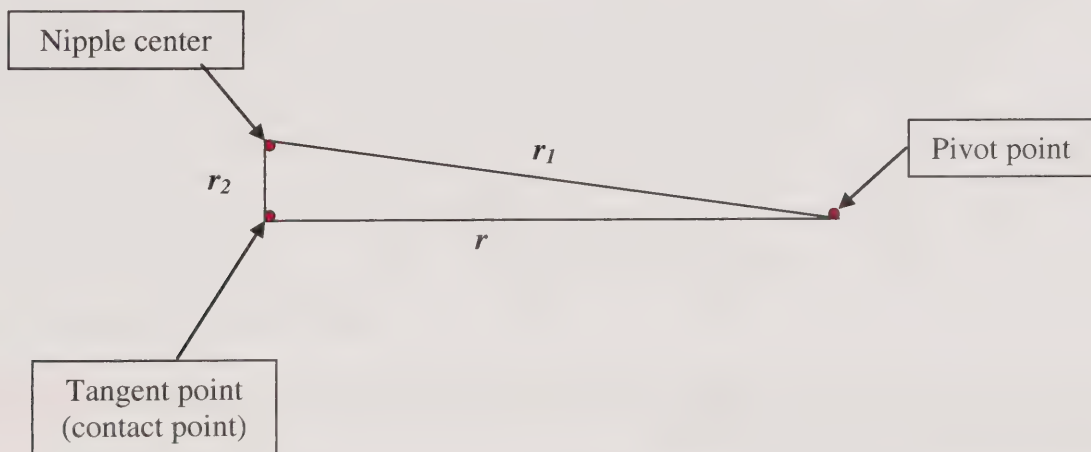
Figure 2: Right angle triangle made by the pivot point, the tangent point, and the center of the nipple

Distance between pivot point (center of the bolt) and center of nipple (r_1) is:

$$r_1 = 37 \text{ inches} / 2 - (37 \text{ inches} - 35 \text{ inches}) = 16.5 \text{ inches}$$

And the angle θ' is: $\theta' = \cos^{-1}(r/r_1) = 5.3^\circ$

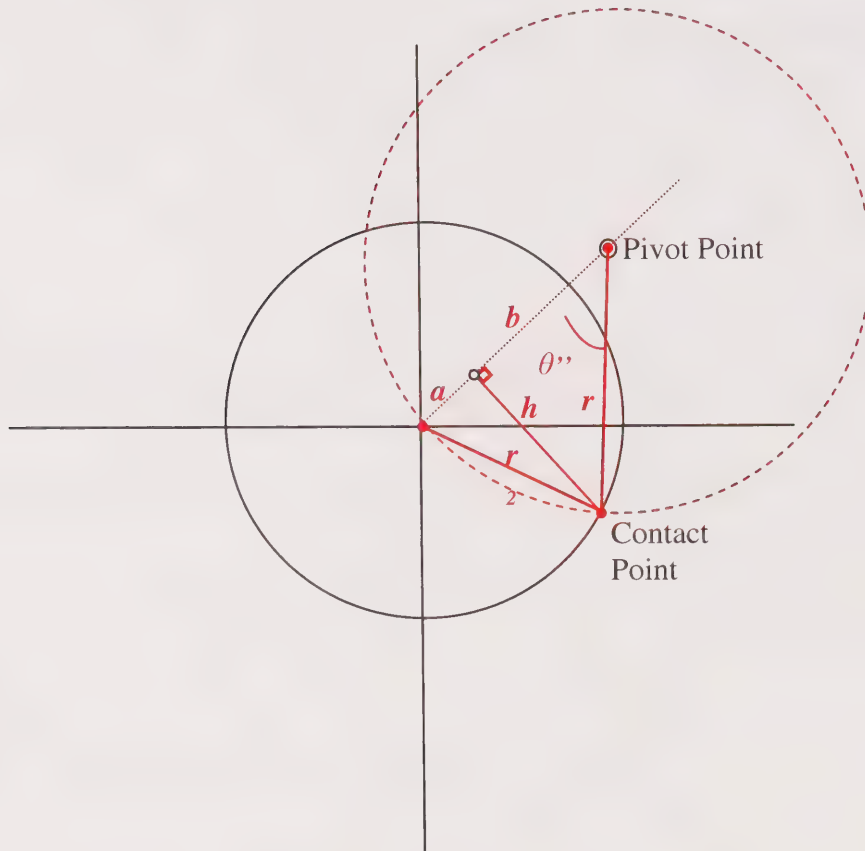
Figure 3: Determining θ'' , the rotation angle between the contact point on the inner surface of the weld neck flange and the center of the flange (not to scale)

Determining θ'' , the rotation angle between the contact point on the inner surface of the weld neck flange and the center of the flange:

Two right angle triangles of height h are forming the bigger triangle made of the center of the flange, the pivot point, and the contact point on the inner surface of the weld neck flange. The first right angle triangle is made of the segment a , h and r_2 , r_2 being the inner radius of the weld neck flange (11.5 inches). The second right angle triangle is made of the segment b , h , and r , r being the radius of the arc between the contact points (16.43 inches). Also, the sum of the segments a and b is equal to the distance between the pivot point and the center of nipple which is r_1 (16.5 inches). Solving for the 3 equations below, we can determine that segments a and b are 4.08 inches and 12.42 inches respectively. Consequently:

Based on the contractor employee interviews, the intent of the rotation movement of the weld neck flange was to bring the weld on the 45° tee to the vertical position in order to facilitate the welding of the cap pass. This would require a rotation of 45° of the weld neck flange and therefore would cause contact between the inner surface of the weld neck flange and the nipple, as the maximum allowable rotation angle to avoid this contact is only 35.6° . The interviews with the contractor revealed that the rotation happened in two movements: a primary larger rotation that brought the weld to an approximate 80° position and then a smaller secondary rotation where the failure occurred. Based on the calculations above, it would have been possible to rotate the weld neck flange up to 80.6° ($45^\circ + 35.6^\circ$) before contacting the nipple cap. Any further rotation would have required the nipple to bend. The interview statements are therefore consistent with the above calculation.
